DOT HS 811 060

December 2008

Commercial Medium Tire Debris Study

Final Report

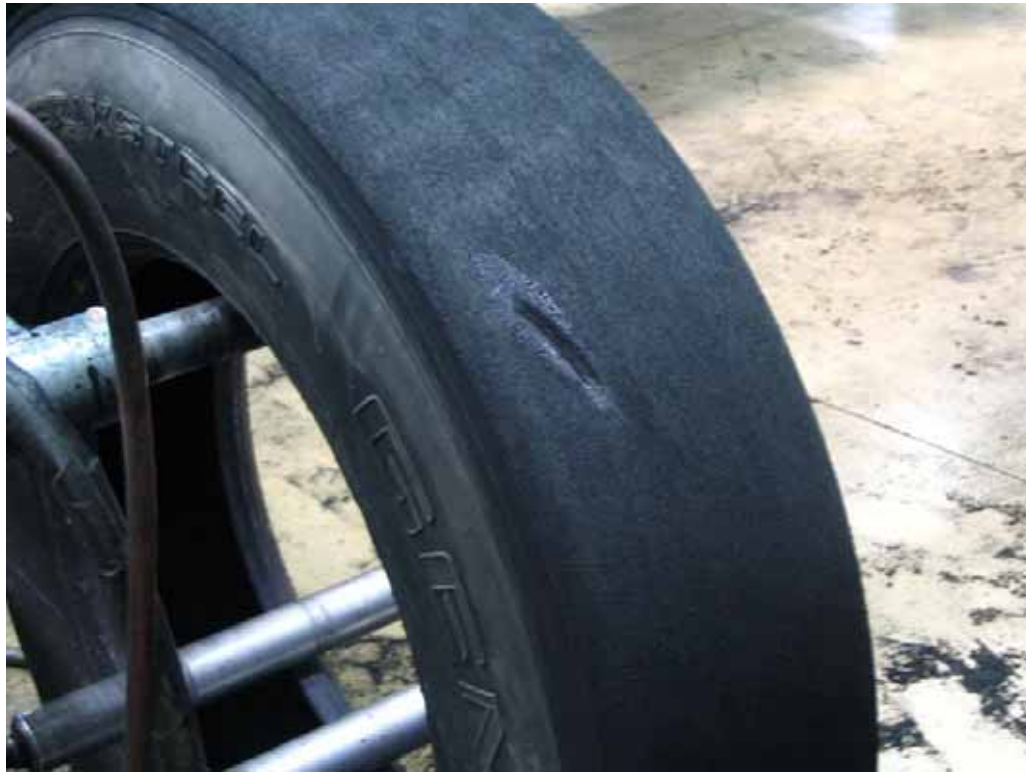
Figure 2.9 – A Buffed Casing Showing Area in Need of Repair

Removal of the old tread may expose minor defects which are then repaired (Figures 2.9 and 2.10). Any injuries identified are determined repairable or nonrepairable. Casings that do not meet the required retread standards (after any attempted repair) at this stage of the process are rejected.

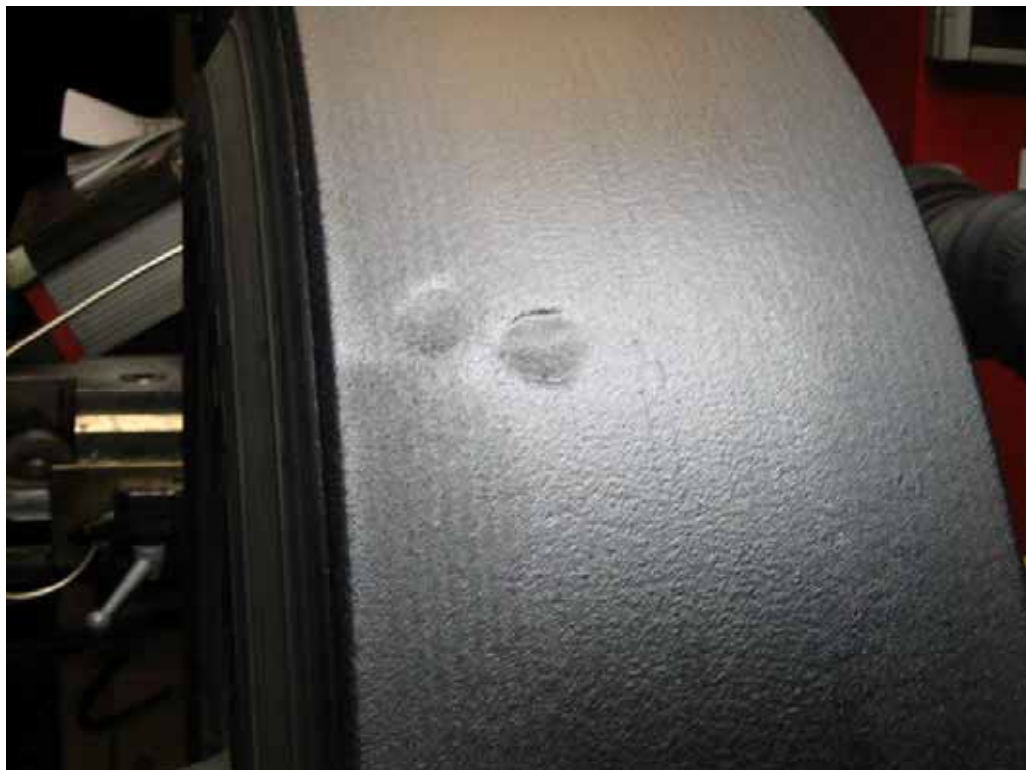
Figure 2.10 – A Buffed Casing After Required Repair

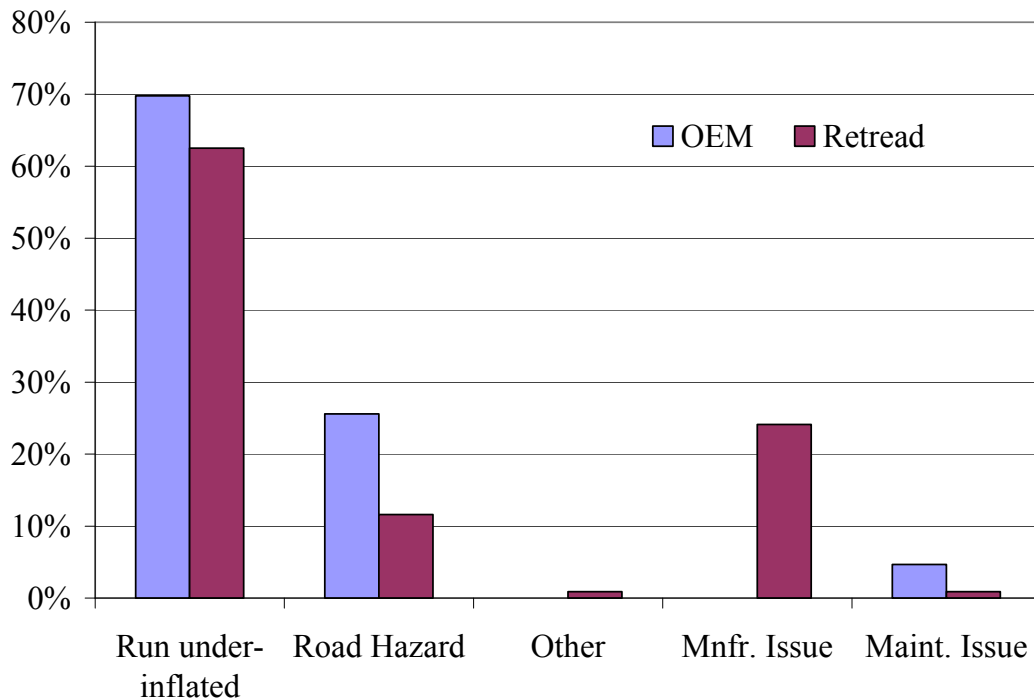
Approximately 155 tires identified (31%) were medium- or wide-base truck tires; 213 were passenger cars (43%), and 127 were light trucks (26%). It should come as no surprise that the percentages of identified tire debris differ from that found in other studies such as the TMC (see section 3.2). However, the extent and type of tire debris found on the Nation’s highways is a function of location, permissible speeds, weather, vehicle mix, etc. Figure 3.5 presents results of the probable causes of failure for the truck tires identified.

Figure 3.5 - Probable Cause of Failure for Truck Tires in Metropolitan Phoenix, 1999

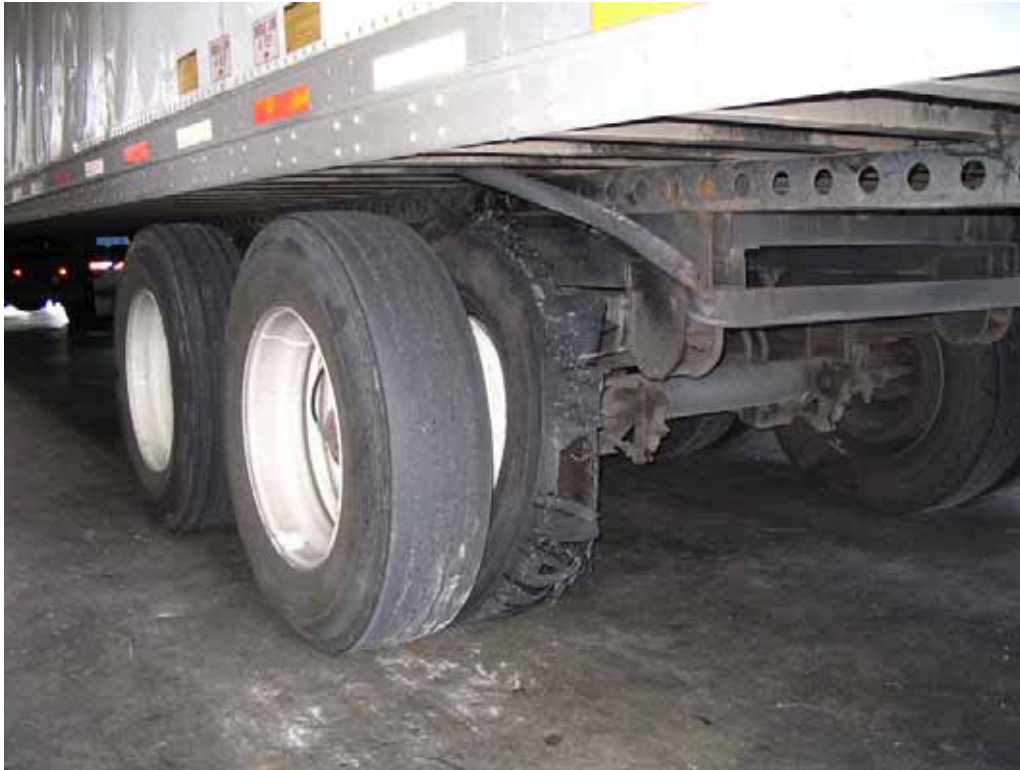
Figure 5.1 – A Failed Medium-Duty Truck Tire

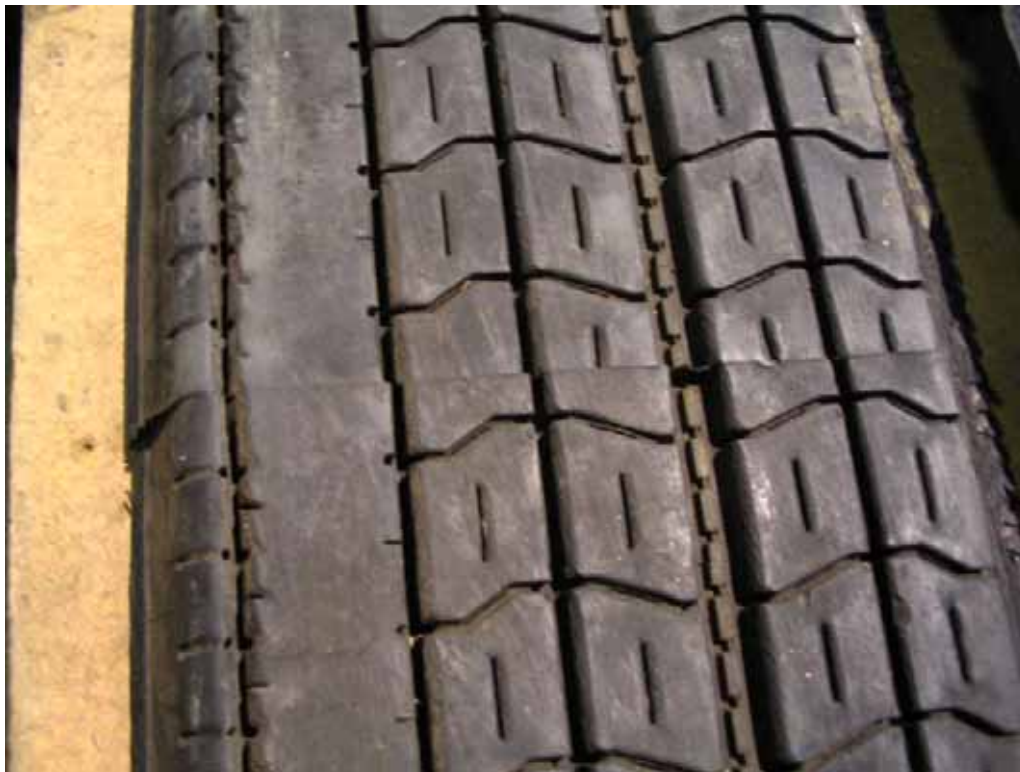
The above problems (though rare) emanating from retread splicing are often used as selling points promoting retread tire processes that do not use splicing (e.g., ring tread or mold cure). Figure 5.4 indicates a misaligned splice on a retread.

Figure 5.4 – Misaligned Splice on a Pre-Cure Retread Casing

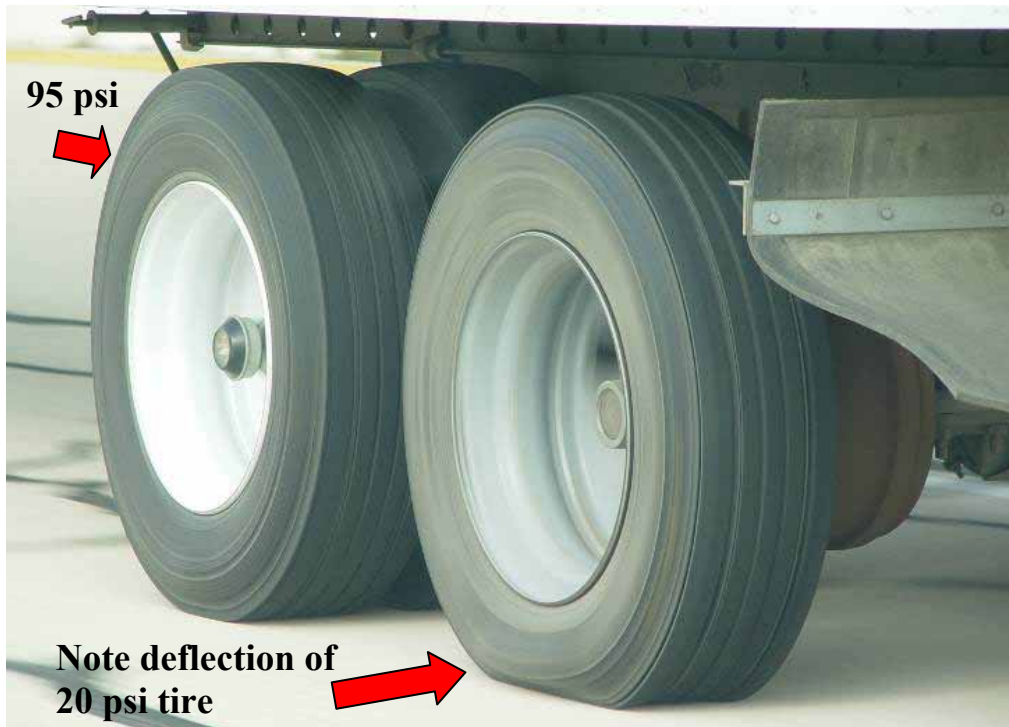
40 percent of the tire's rolling resistance while the tread accounts for 60-70 percent" (Kenworth Truck Company, 2003). Thus, shorter journey times may make a trucking operation more competitive, but they may also have long-term negative impacts increasing tire costs. Figure 5.5 illustrates an underinflated tire operating at high speed. Overdeflection of the underinflated tire is noticeable (when compared to the correctly inflated tire) and the resulting footprint is suboptimal.

Figure 5.5 – Underinflated Tire

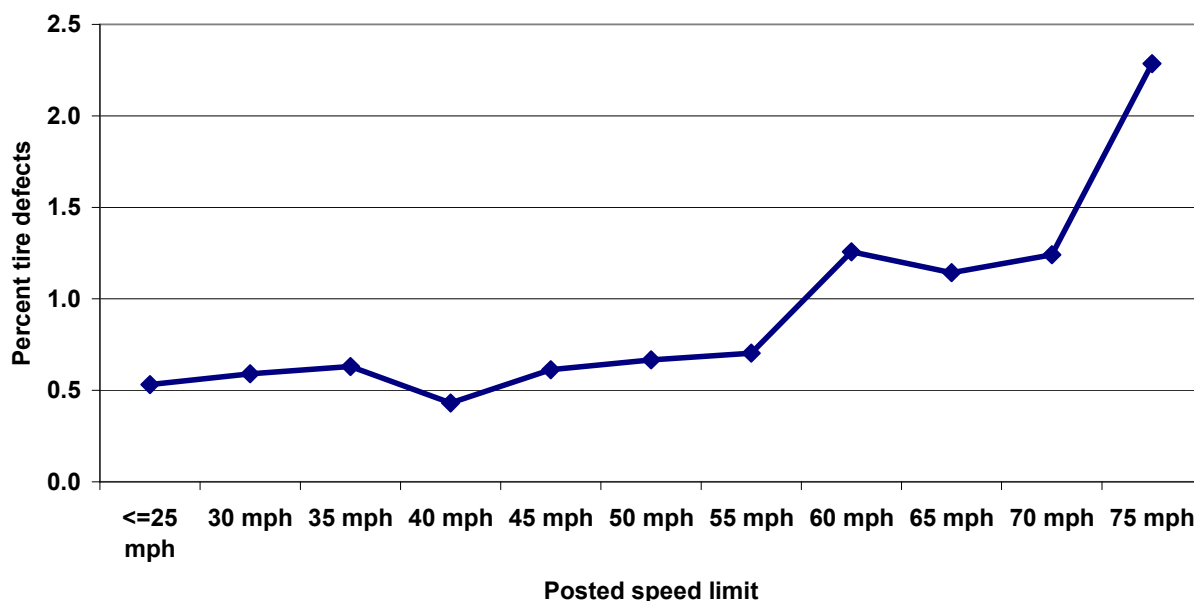
The effect of road speed is more directly shown in Figure 7.6, which shows the percentage of tire defects identified in crashes by the posted speed limit on the road. The incidence of tire defects stays low at around 0.6 percent on roads with posted speed limits up to 55 mph. On roads with speed limits from 60 mph to 70 mph, the percentage essentially doubles to about 1.2 percent, and then doubles again to 2.3 percent on roads with posted speed limits of 75 mph. In combination with the distribution of tire-defect-related fatal truck crashes by route signing, this suggests that high speeds and the related heat generated are associated with the incidence of tire defects.

Figure 7.6 – Incidence of Tire Defects in Fatal Crash Involvements by Posted Speed Limit, TIFA 1999-2005

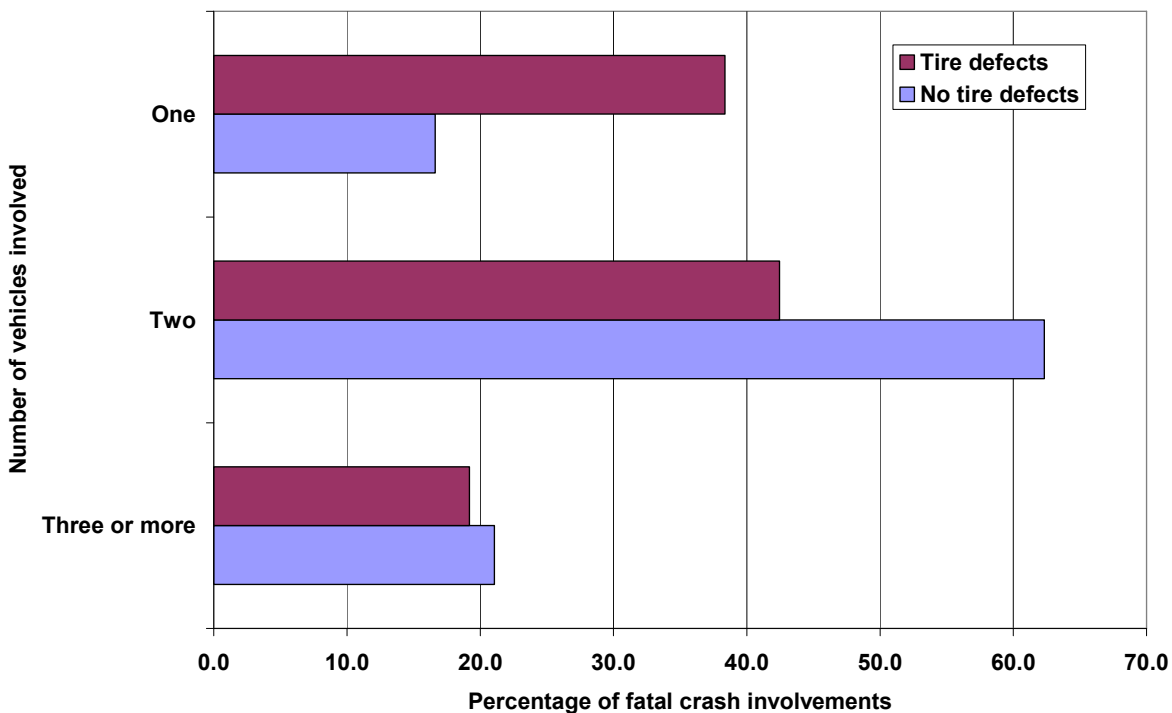
Trucks with tire defects in fatal crashes are much more likely to be involved in single-vehicle crashes than other trucks. Figure 7.7 shows that about 38 percent of fatal crashes involving trucks with tire defects are single-vehicle crashes, compared with only about 17 percent for other trucks. Accordingly, the percentage of two-vehicle crashes is much lower (42.5% compared to 62.3%) for trucks not coded with tire defects, though the percentage of involvements with three or more vehicles is about the same.

Figure 7.7 – Distribution of Tire-Related and Other Fatal Crash Involvements by Number of Vehicles Involved, TIFA 1999-2005

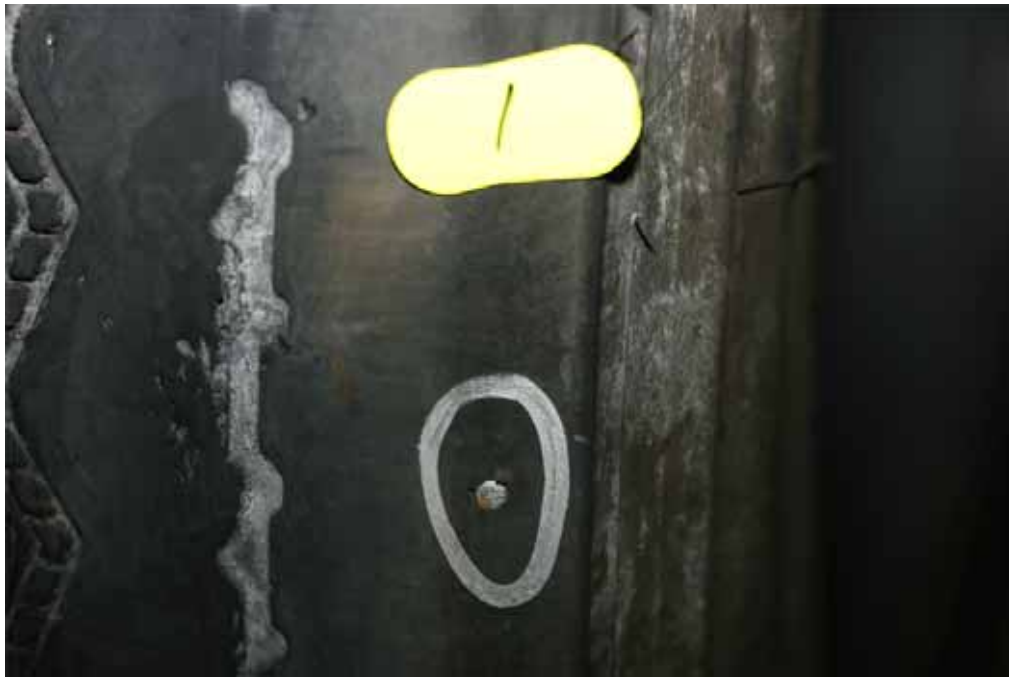
Figure 9.2 - Overdeflected Operation #1 - Apparent nail in outer rib, resulting in slow air loss and flex fatigue damage

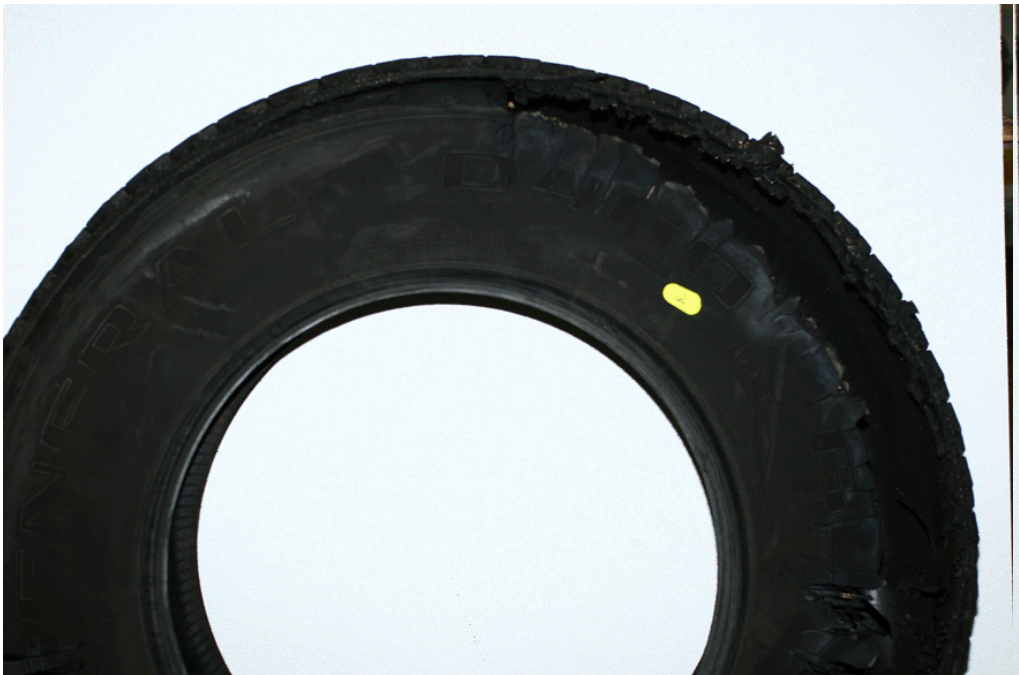
Figure 9.3 - Overdeflected Operation #2

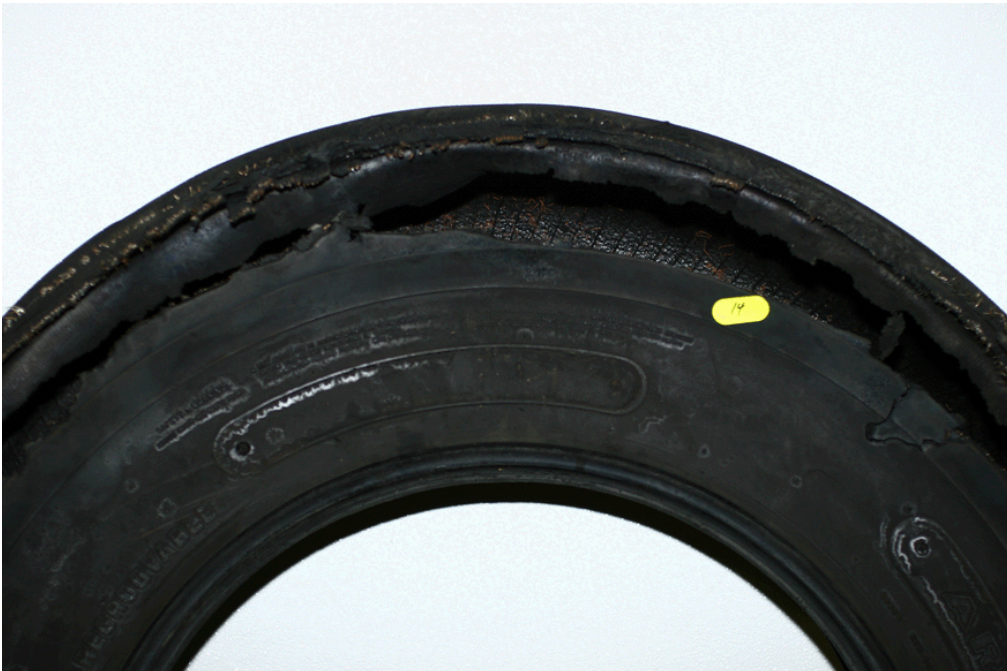
Figure 9.5 - Excessive Heat #2 (Original tread with very significant heat damage (bright bluish discoloration), including localized reversion of rubber)

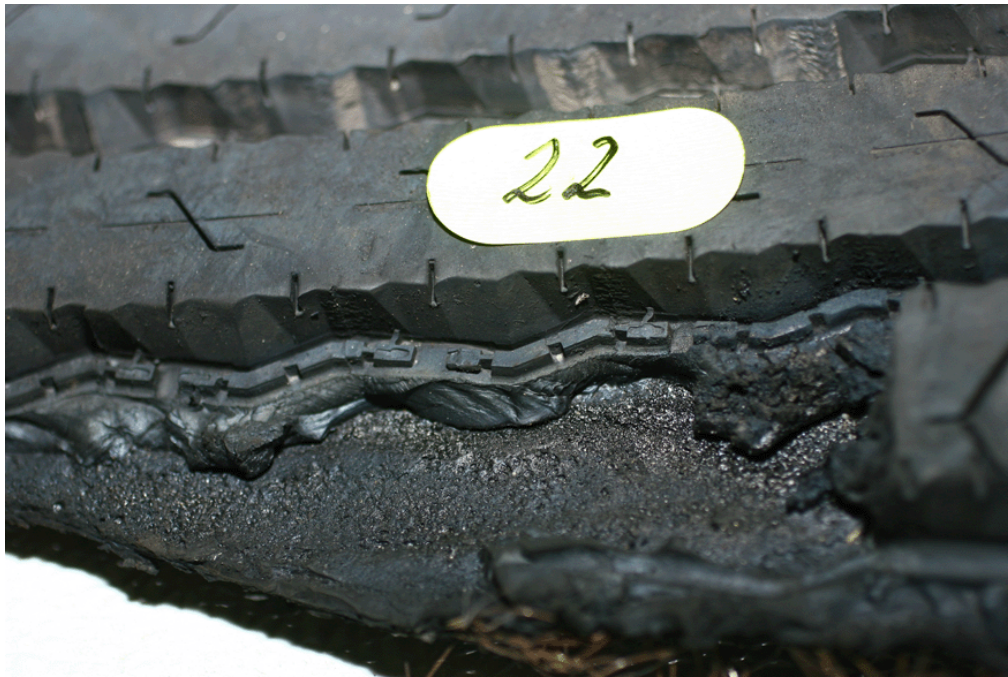
Figure 9.6: Excessive Heat #3

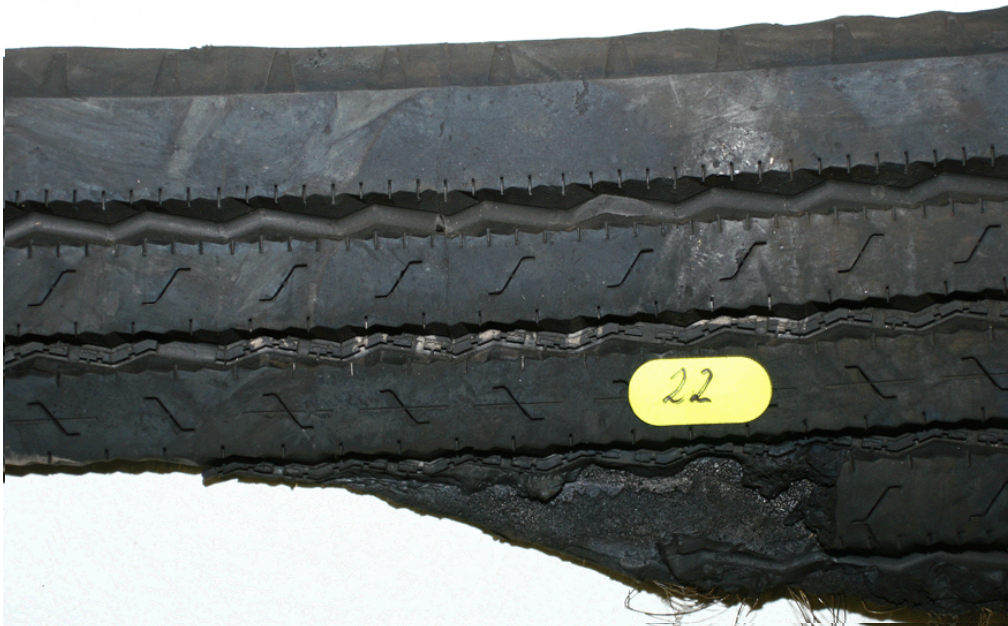
Figure 9.7: Excessive Heat #4

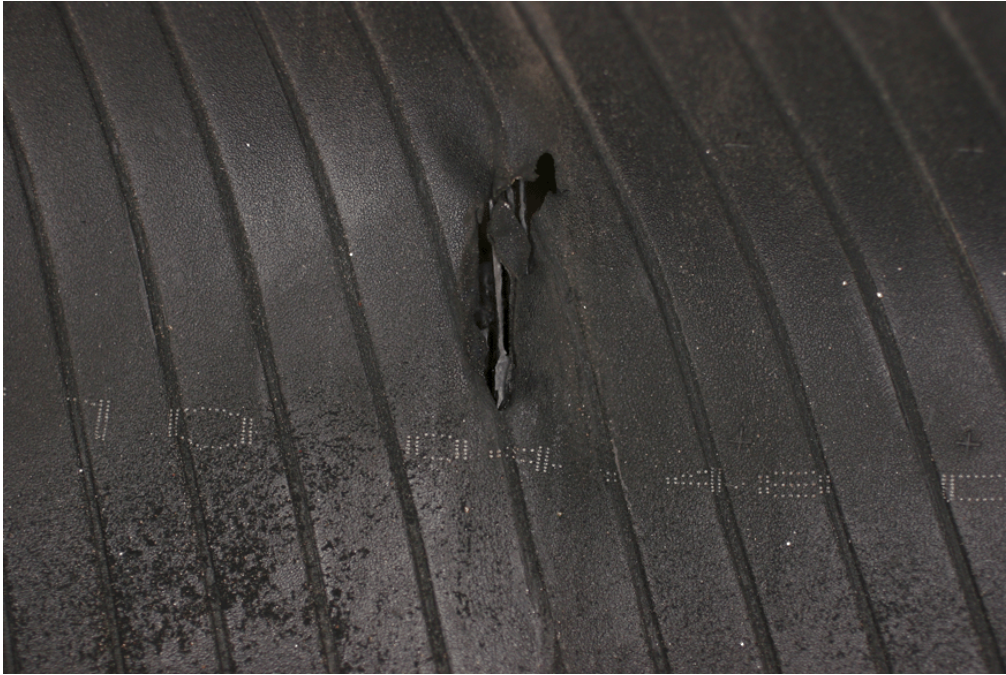
Figure 9.8 - Road Hazard #1 - Pinch shock damage. Sidewall separation resulting from excessive intracarcass pressurization, allowed by the pinch shock injury

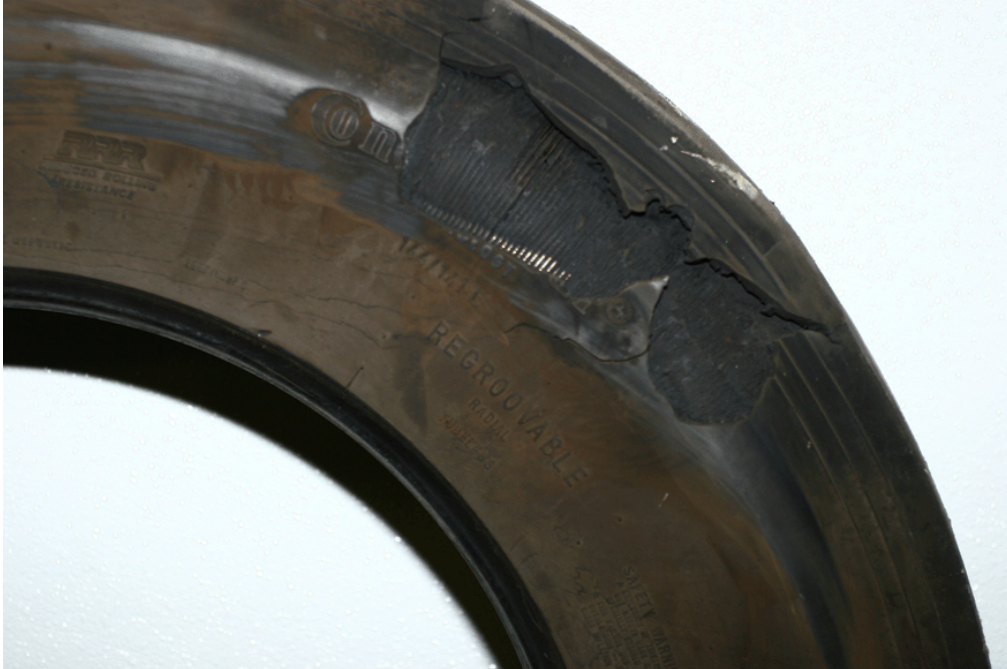
Figure 9.9 - Road Hazard #2 - Pinch shock damage. Sidewall separation resulting from excessive intracarcass pressurization, allowed by the pinch shock injury

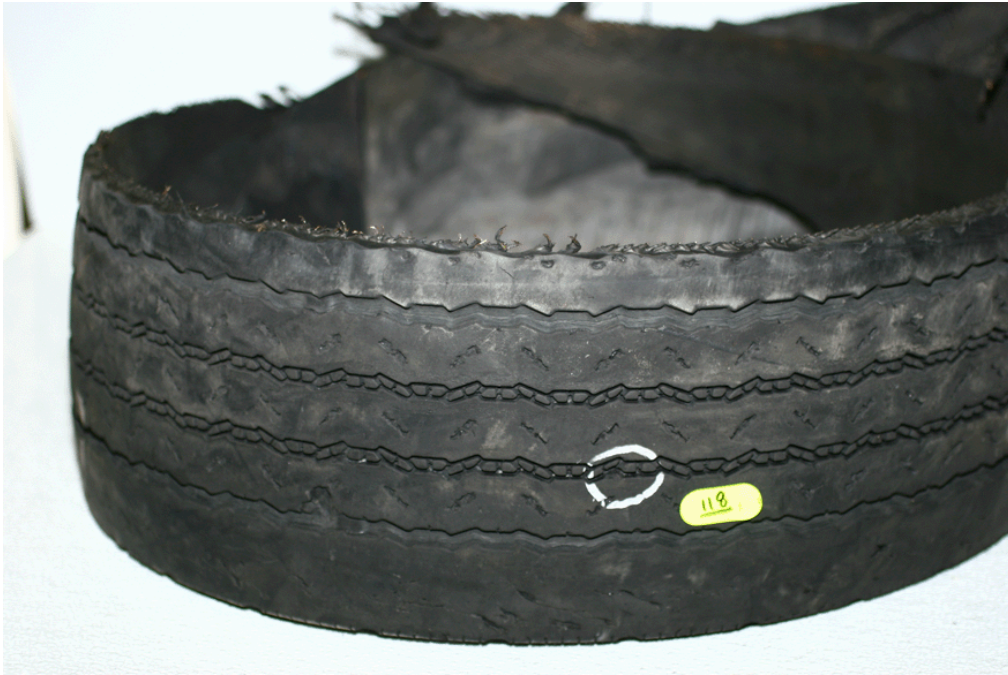
Figure 9.10 - Road Hazard #3 - Unrepaired crown puncture in original tread

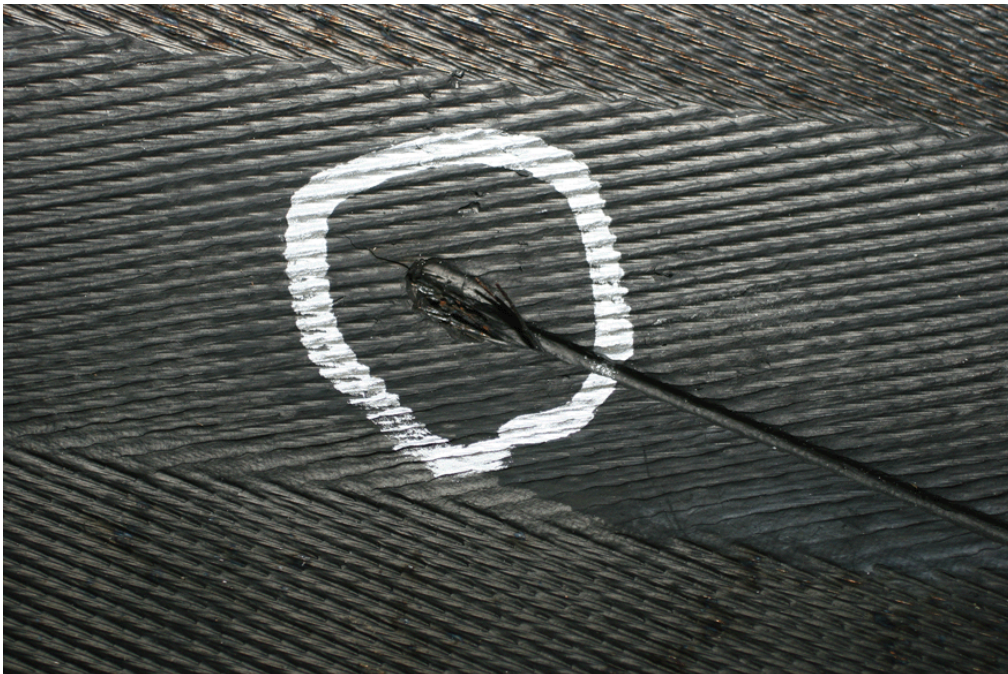
Figure 9.11 - Road Hazard #4 - Unrepaired crown puncture in original tread

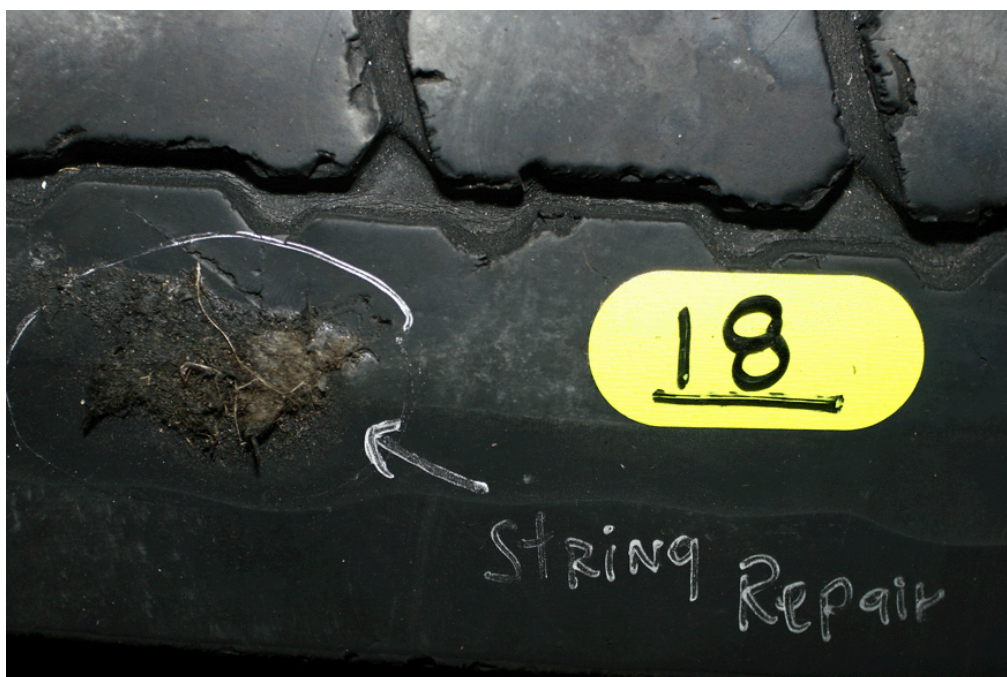
Figure 9.12 – Maintenance/Operational #1 - Use of improper (outside-in string plug) repair. Resulted in excessive intracarcass pressurization, sidewall separation, and tire failure

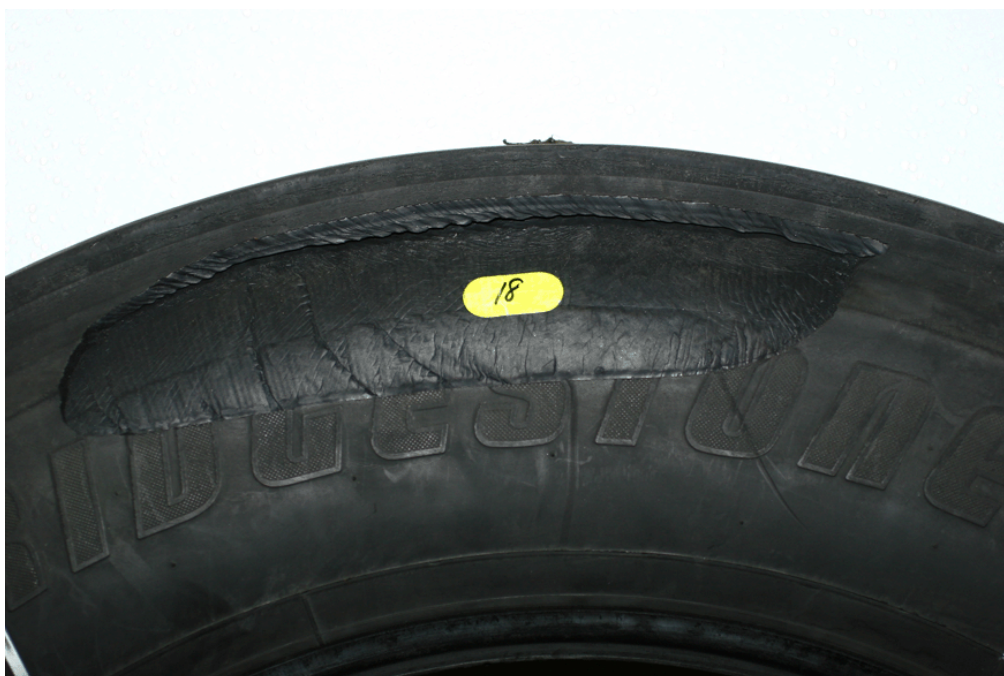
Figure 9.13 – Maintenance/Operational #2 - Use of improper (outside-in string plug) repair. Resulted in excessive intracarcass pressurization, sidewall separation, and tire failure

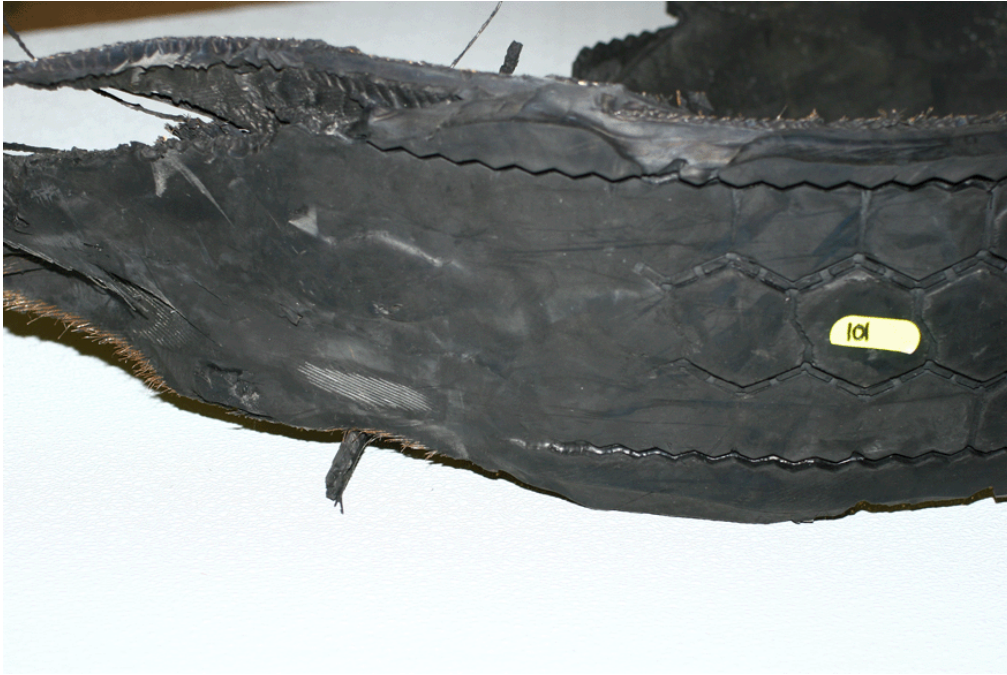
Figure 9.14 – Maintenance/Operational #3 - Example of drive axle tire with localized accelerated wear

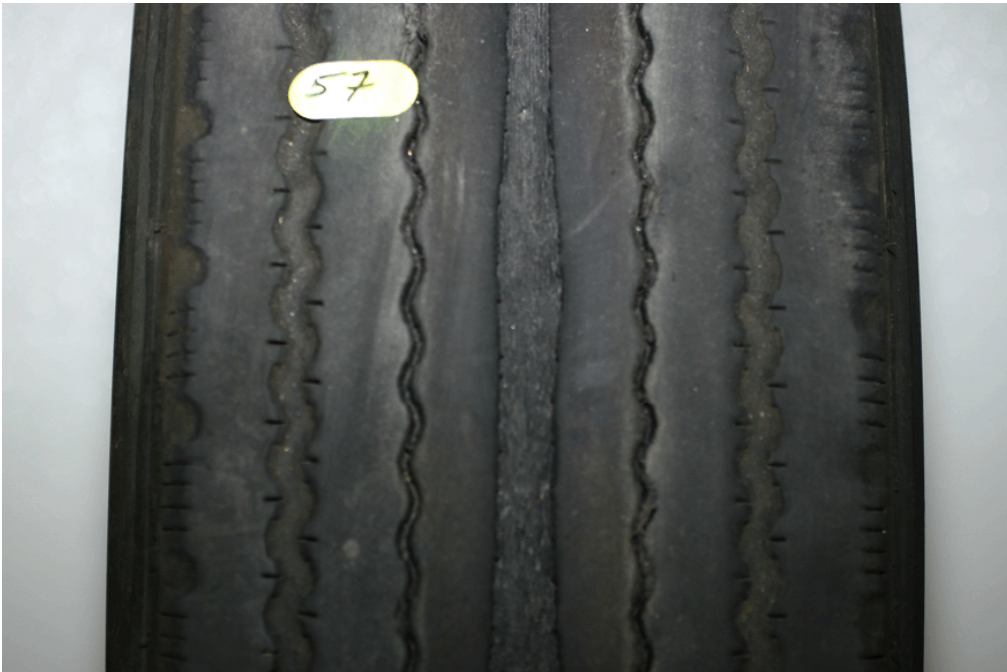
Figure 9.15 - Manufacturing/Process Issues #1 - Retread rubber separated at buff line. This resulted in a "raised" section of the tire's circumference. Localized, accelerated wear (9" in the center of the tread) resulted, extending to the buff line.

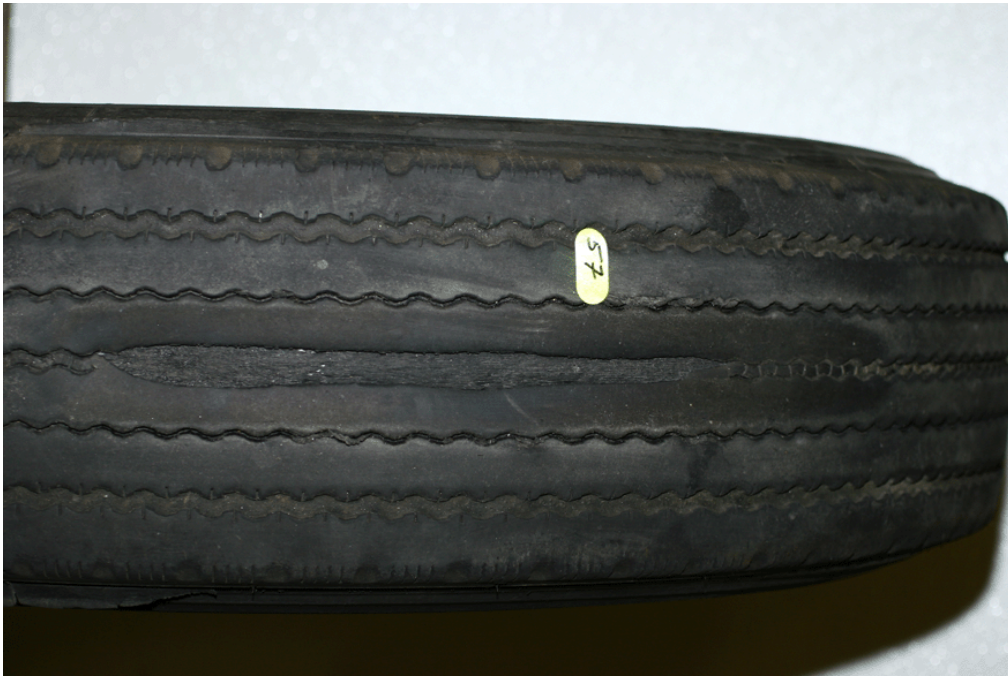
Figure 9.16 - Manufacturing/Process Issues #2 - Retread rubber separated at buff line. This resulted in a "raised" section of the tire's circumference. Localized, accelerated wear (9" in the center of the tread) resulted, extending to the buff line.

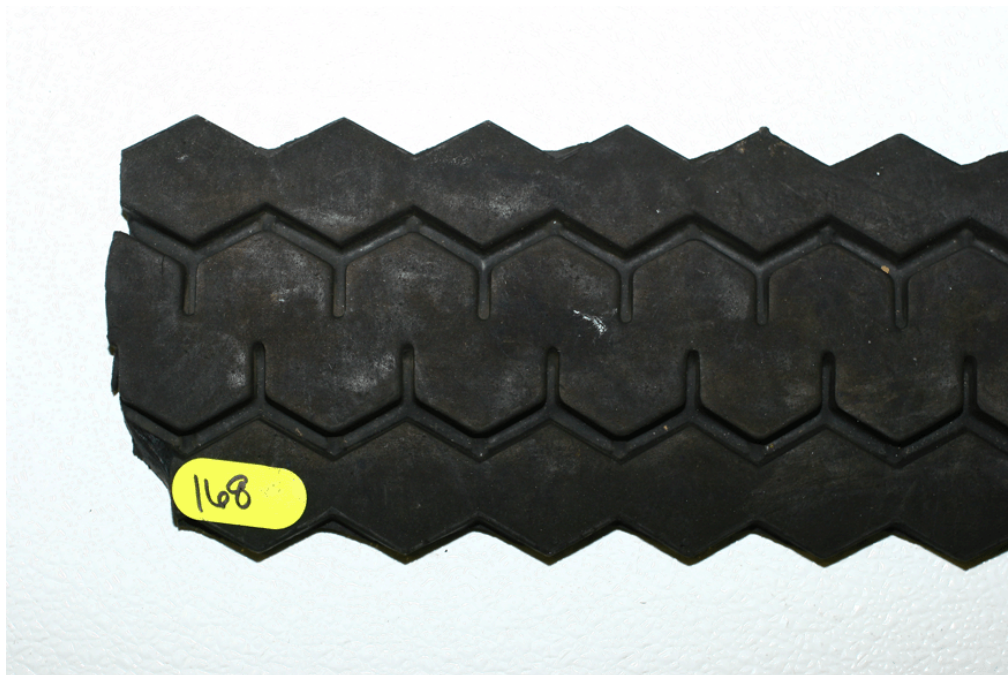
Figure 9.17 - Manufacturing/Process Issues #3 - Bond failure at buff line

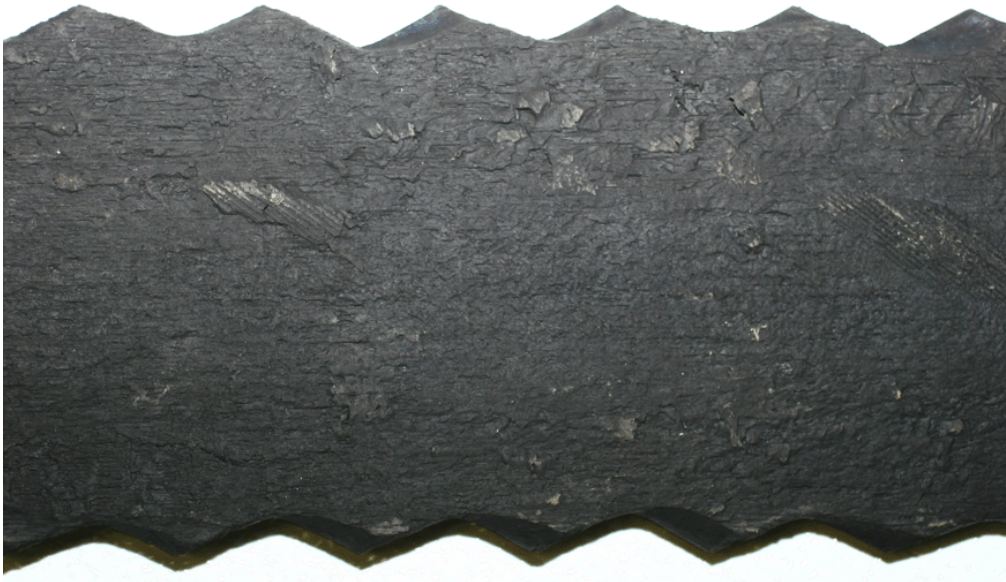
Figure 9.18 - Manufacturing/Process Issues #4 - Bond failure at buff line

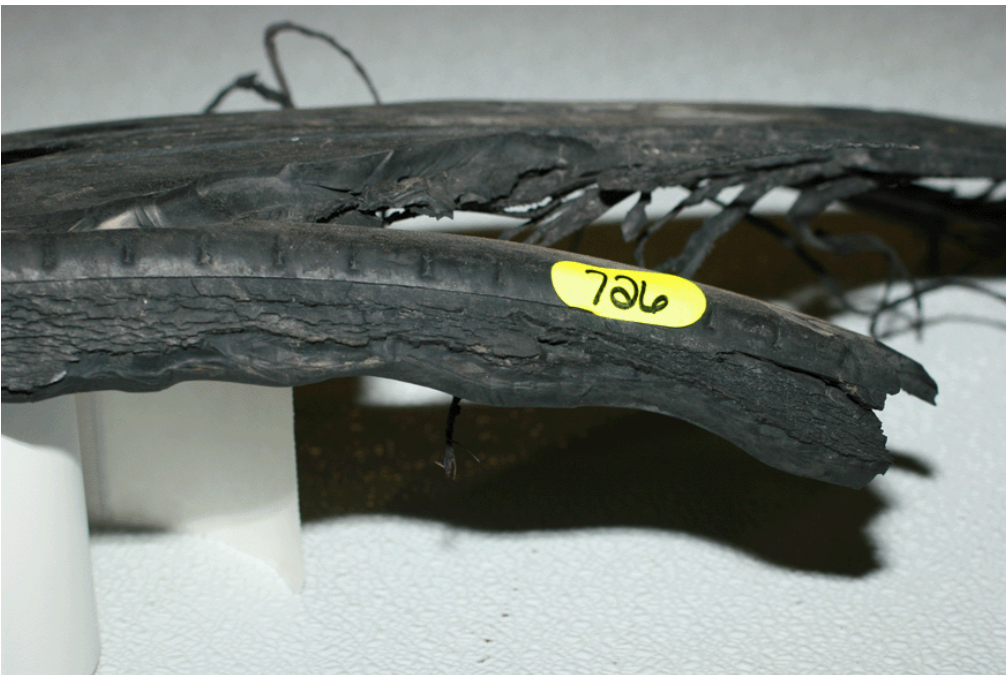
Figure 9.19 - Manufacturing/Process Issues #5 - Tire may have been unsuitable for retreading (severe weather cracking)

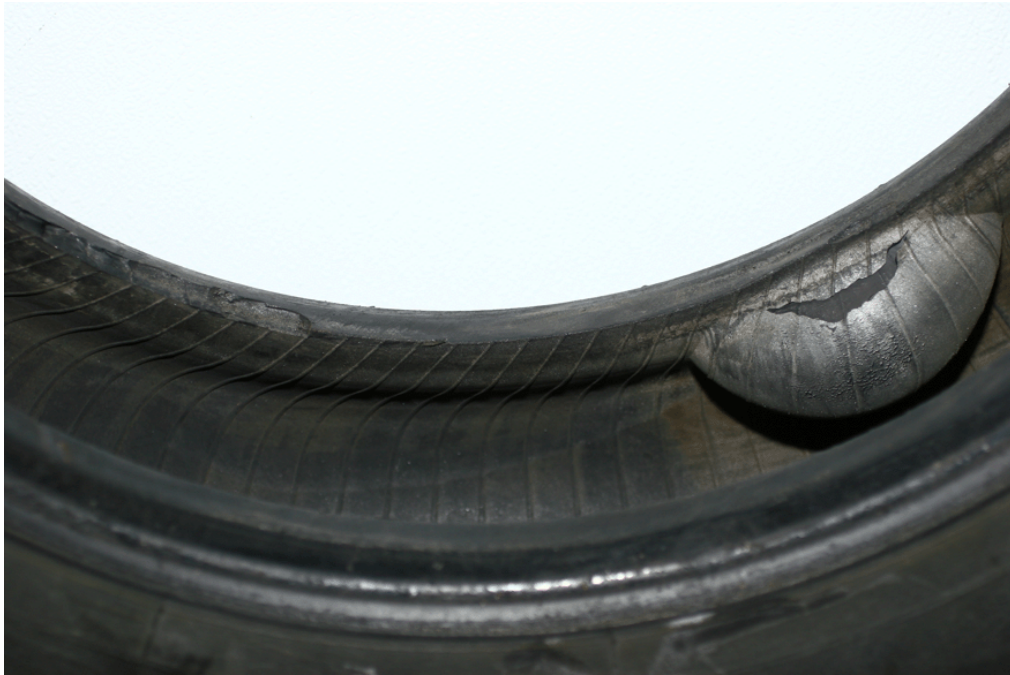
Figure 9.20- Excessive Intra-carcass Pressurization #1 - Separation as a result of excessive intracarcass pressurization
